# WATER OPERATION AND MAINTENANCE

**BULLETIN NO. 148**

June 1989

Buried Irrigation Pipe at Carrington Irrigation Station Foundation Drain Maintenance Methods Reinforced Bitumen Canal Lining Some Good Tips on Spray Tips How To Select a Spray Tip Spotlight on Calamus Dam and Reservoir

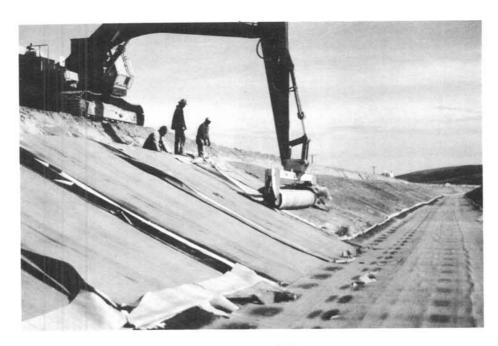
Placement of liner

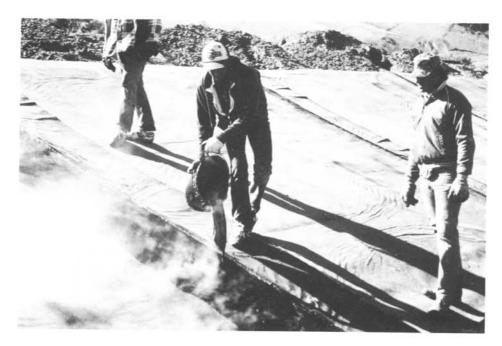
Joint sealing

The joints are sealed by pouring hot roofing asphalt on the joint surfaces and applying pressure. The roofing asphalt provides a uniform heat source to melt the rubberized asphalt in the joint area of each sheet so they will adhere. A 20-inch joint area of the strip film on each edge of the liner is left free of slate to allow proper sealing of the seams. Early installations done in Canada used torches to heat the material and seal the seams. This procedure was found to be unreliable as some seams were not heated enough and the seams leaked, and in other areas the material was overheated and the rubber was burned out of the asphalt. We have found one minor problem with the installation. The bead of roofing asphalt poured over the edge of the seam following sealing of the joint tends to slough at high ambient temperatures, particularly on south facing slopes. In the future, the District will either eliminate the bead entirely or place it only as high as the waterline. The bead is installed for an added margin of safety

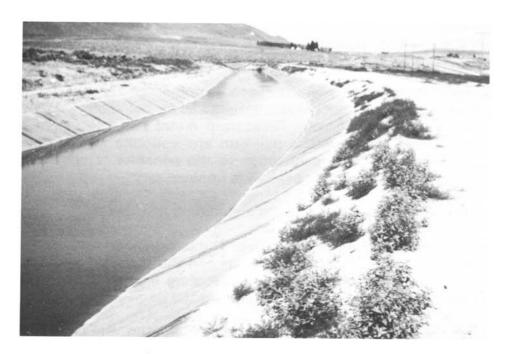
Completed project, Main Canal

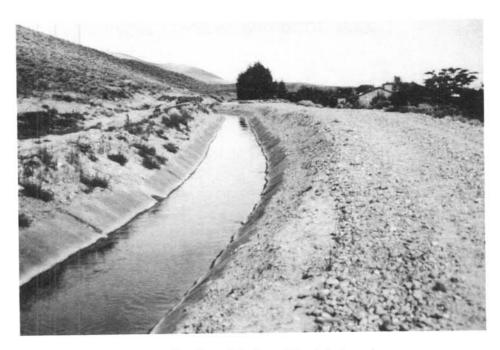
Completed Project, Badger East Lateral

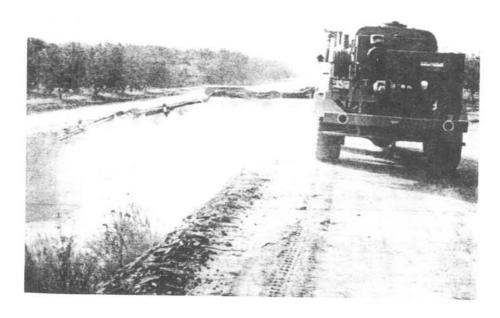
Herbicide application on irrigation ditch with adjustable boom

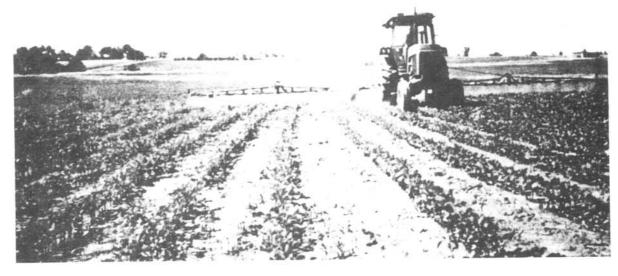
At proper height, the sprayer should provide an even amount of chemical across the full width of the boom

The optimum height setting varies with individual booms, and normally it requires fine-tuning once the spray tips are mounted. If available, a spray table is ideal for checking the uniformity of the spray, which can be affected by height.

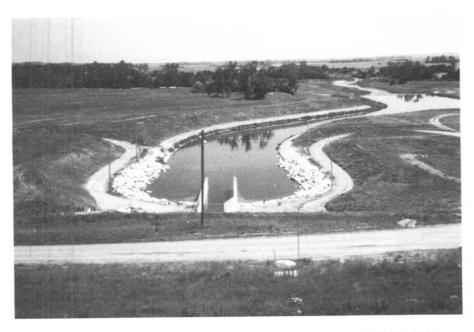
Calamus Dam - Spillway discharge channel. 6/7/88
